**JAV
ESTIMATING
SERVICES, INC**

SUMMARIZED INSPECTION REPORT

REPORT NUMBER- 090800

FOR THE PROPERTY LOCATED AT-
YOUR ADDRESS HERE
RENO, NEVADA

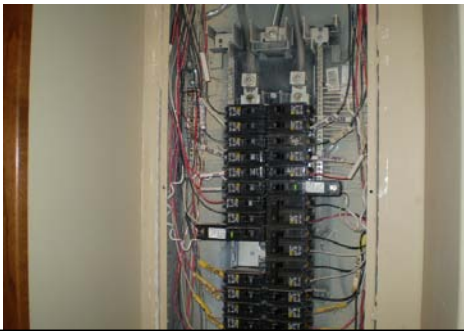
PHOTO #1 MISSING BUSHING WHERE ROMEX ENTERS BOTTOM OF SUB PANEL AT PANTRY

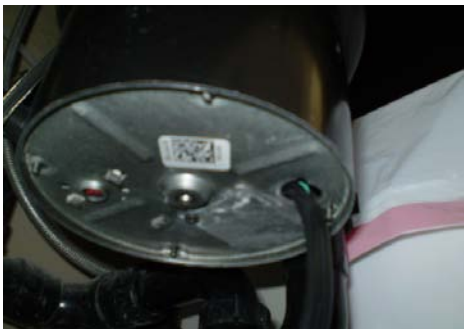
PHOTO #3 WIRES NOT SECURED TO DISPOSAL AT KITCHEN SINKS- (2)

4.12- **Disposal wires**- Secure the wires at the base of the disposal to prevent loosening of connections. Under both garbage disposal units.

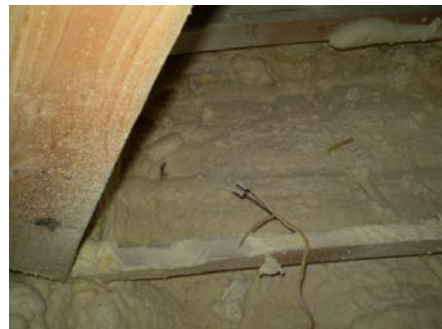
PHOTO #4 ABANDONED WIRES IN ATTIC- NEAR NOOK

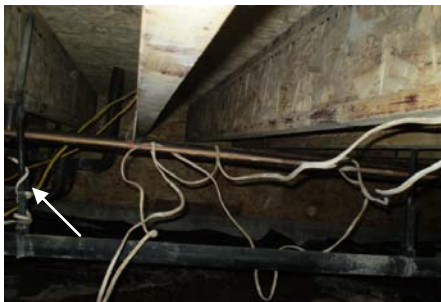
PHOTO #5 UNSUPPORTED WIRES, ABANDONED WIRES- CRAWL AREA BELOW KITCHEN

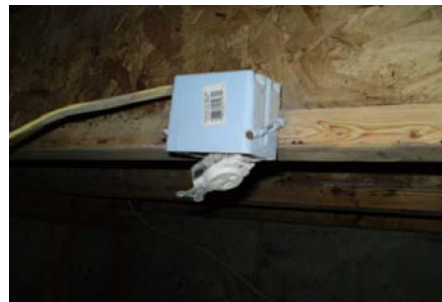
PHOTO #6 LOOSE OUTLET, INCOMPLETE WIRING, MISSING COVER UNDER ENTRY

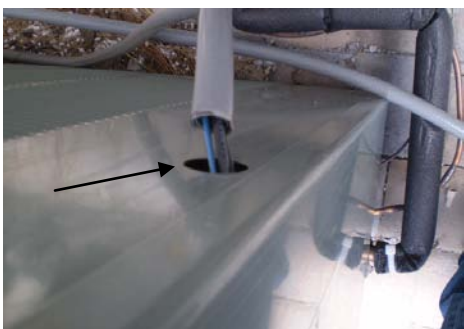
- 3.24- AC power conduits- conduits are loose and separated at the condensing units at the exterior south- NEC 370-17
 - 3.25- Water softener air gap- No air gap or back flow device was visible at the water softener unit in the garage. UPC 603

PHOTO #7 CONDUITS NOT SECURED TO BOTH AC UNITS

4.24- **AC power conduits**- The power supply conduits are separated from the ac condensing units. Water may enter the exposed conduit ends and the wires may be damaged from rubbing over the sidewall of the condensing units frame. Align and secure the loose conduits as needed: 2 each south.

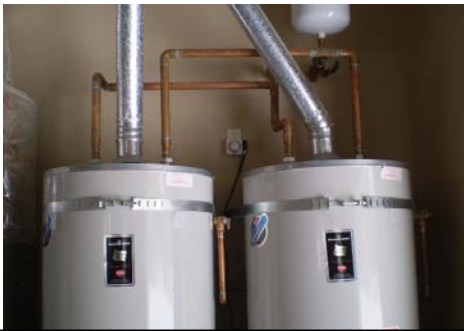
- 3.22- Drip leg at water heaters- No drip legs are installed in the gas lines at the water heaters in the garage – UPC 1211.4
 - 3.23- Heater service/activate- units are deactivated. Units are dirty. Units have water marks within indicating past condensation leaks from exhaust. UBC 310-11

PHOTO #9 WATER HEATERS AT GARAGE. NO DRIP LEGS IN GAS LINES PRIOR TO REGULATORS

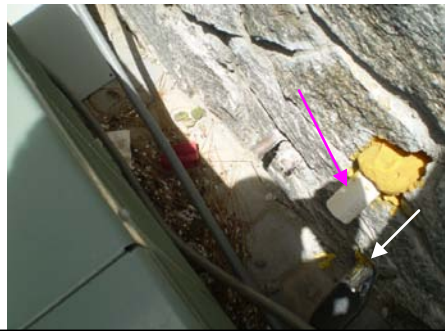
PHOTO#10 NO ELBOWS ON WATER HEATER TP VALVES BEHIND AC SOUTH. NO PAINT AT PVC

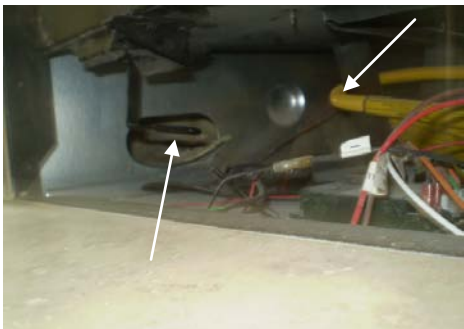
PHOTO #11 FLEX GAS LINE RUGS ON SUPPORT AT MASTER FIREPLACE. FOAM INSULATION BLOCKS AIR FLOW

4.26- **Master fire place gas line**- the flex gas line is rubbing against a main support under the fire place unit. This may cause damage to the gas line. Provide proper clearance from the flex line to sharp metal supports that can damage the connector pipe.

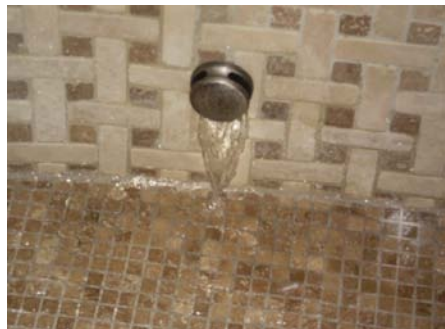
PHOTO #12 WATER FLOWS FROM MR. STEAM, NOT STEAM

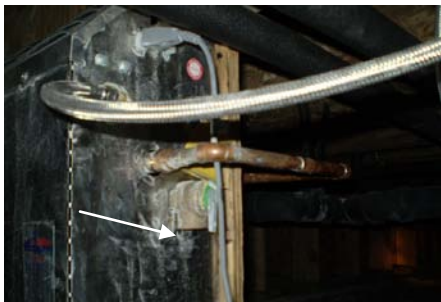
PHOTO #13 NO DRAIN LINE ON MR. STEAM TO VALVE IN CRAWL AREA

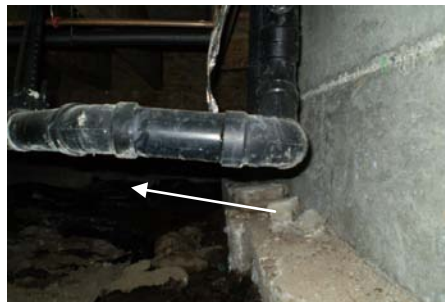
PHOTO #14 WASTE LINE FLOWS UP HILL TO EXIT UNDER KITCHEN

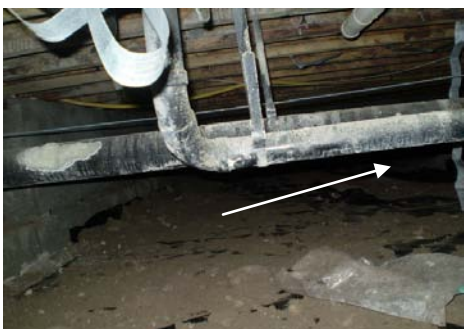
PHOTO #15 UP HILL SLOPE OF WASTE LINE BELOW WEST BATH

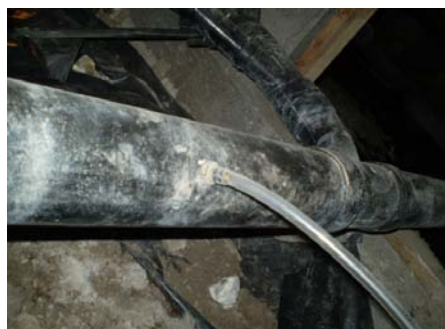
PHOTO #16 FLEX DRAIN LINE TAPS INTO WASTE LINE. POSSIBLE CROSS CONNECTION-

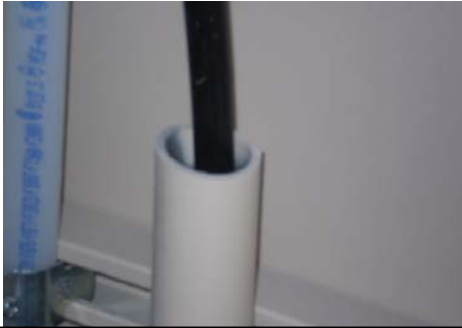
PHOTO #17 WATER SOFTENER DRAINS DIRECTLY TO WASTE LINE. NO ANTI-SIPHON OR BACK FLOW DEVICE VISIBLE- GARAGE

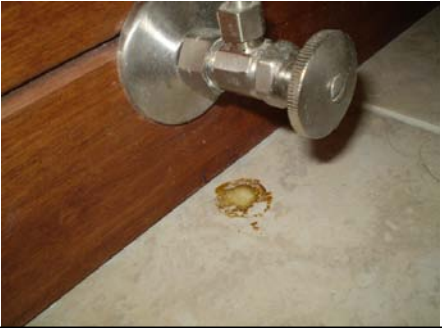
- 3.210- Leak toilet supply- west bath has leak at the supply line – UPC 310
 - 3.211- Plumbing support crawl area- Several support straps are missing or broken at both supply and waste lines throughout the crawl area- UPC 314

PHOTO#18 LEAK AT SOUTH BATH TOILET SUPPLY LINE

4.210- **Leak toilet supply-** west bath- repair the leak at the supply line/angle stop at the west bath toilet.

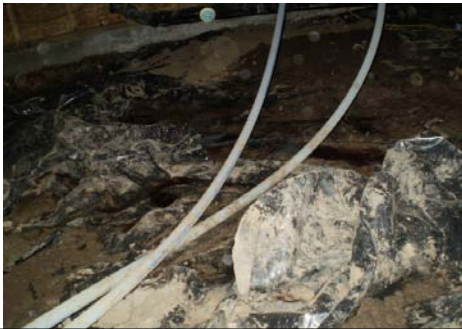
PHOTO #19 UNSUPPORTED WATER LINES.

4.211- **Plumbing support crawl area-** there are several supply and waste lines that are not supported or have broken supports in the crawl area. Install proper supports at both supply and waste lines as required.

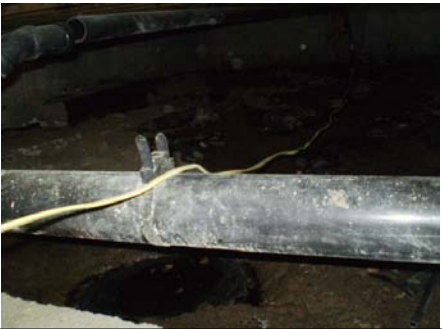
PHOTO #20 BROKEN PLUMBING SUPPORT, CENTER. LOOSE WIRES, STANDING WATER

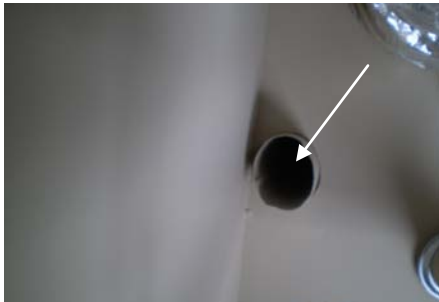
PHOTO #21 HOLE INTO ATTIC ABOVE WATER HEATER. NO FIRE DAMPER. HOLE IN FIRE WALL

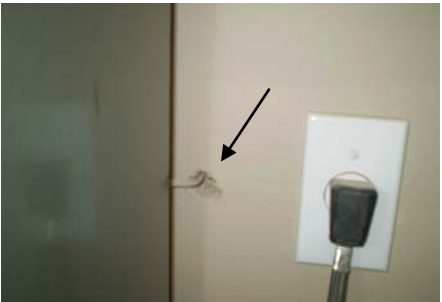
- 3.31- Fire wall- hole behind water heater. No fire tape or fire caulking- UBC 703
- 3.32- Fire wall- duct- open duct through ceiling of garage. No fire damper. UBC 703
- 3.33- Fire wall- flue flanges are loose and fire wall is not maintained. UBC 703
- 3.34- Doors/windows- frames are out of square. Windows and doors do not properly seal. MEC 502.3
- 3.35- Shower door swing- west bath shower door swings in only. Door needs to swing out. UBC 2407
- 3.36- Gaps at cabinet bases- no escutcheons or insulation installed where pipes penetrate the sub floor and cabinet base- wet bar at master bedroom. MEC 502.3
- 3.37- Egress window- west bedroom windows do not open to provide 20" minimum width as required- UBC 310.4
- 3.38- Water damage master bedroom- damage is present from roof leak at east side of master bedroom.
- 3.39- Other
- 3.310- Other
- 3.311- Other

PHOTO #22 NO FIRE CAULKING AT HOLE BEHIND HEATERS AT GARAGE

4.31- **Fire wall-** hole- repair the hole in the garage fire wall behind the heater unit. Install fire tape, fire caulking or other approved materials.

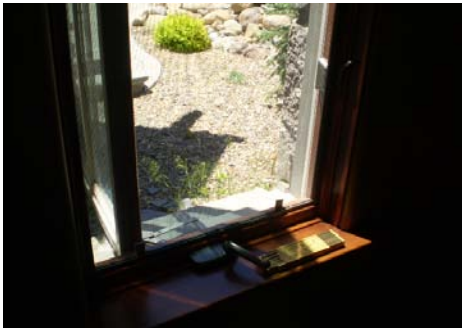
PHOTO #23 WINDOW AT WEST BEDROOM DOES NOT OPEN TO PROVIDE 20" WIDTH FOR EGRESS

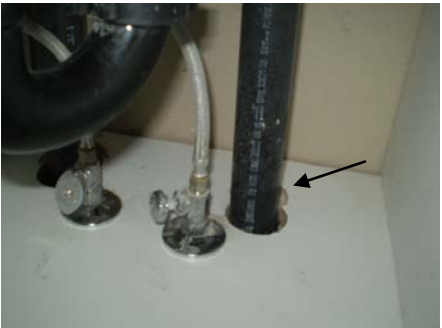
PHOTO #24 HOLES IN CABINET BASE. AIR FLOWS FROM CRAWL AREA. NO INSULATION

4.36- **Gaps at cabinet bases**- there are gaps at the base of the wet bar cabinet where cold air from the crawl area may freely flow to the interior. Install proper insulation and escutcheon plates as needed to prevent air infiltration

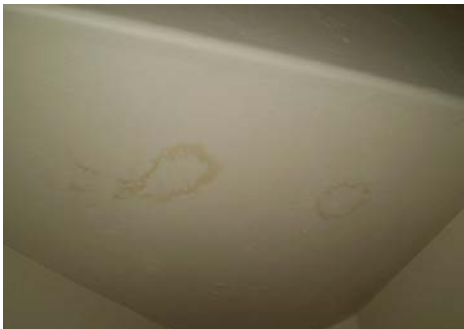
PHOTO #25 WATER DAMAGE AT MASTER BEDROOM CEILING FROM ROOF LEAK ABOVE

4.38- **Water damage master bedroom**- remove and replace the water damaged components in the wall above the master bedroom fire place. Invasive examinations will need to occur to determine the extent of the water damage and possible environmental conditions that may be present.

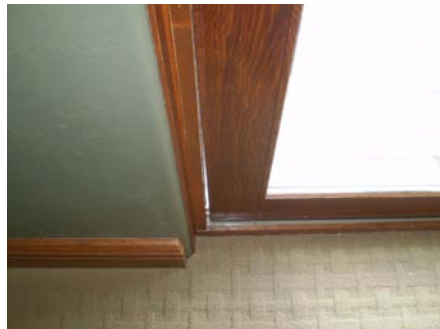
PHOTO#26 DOOR FRAME IS OUT OF SQUARE AT FAMILY ROOM

4.34- **Doors/windows-** door frames are out of square. Doors and windows will not seat securely to prevent air loss. Consult a specialist. Repair or replace the windows, doors and frames as needed to provide proper operation and proper weather sealing of the units.

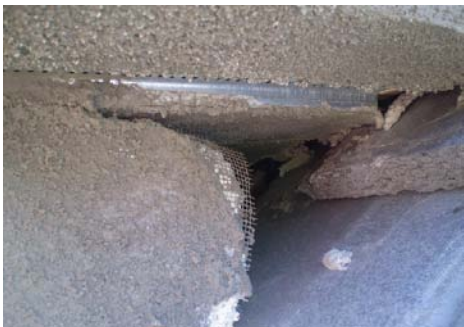
PHOTO #27 HOLE IN EAVE. BIRD, ANIMAL ACCESS TO ATTIC

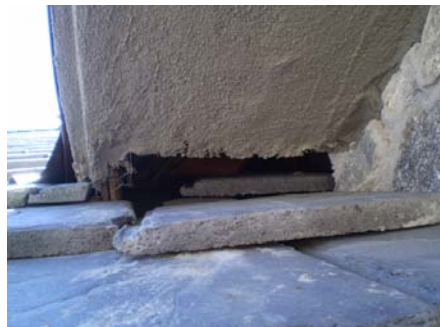
- 3.43- Seal around doors/windows/penetrations- gaps are present where water and air may infiltrate at exterior wall penetrations. MEC 502.3
- 3.44- Openings at eaves- holes are present into the attic where animals and birds may access the attic throughout the perimeter of the building. UBC 1505.3

PHOTO #28 OPENINGS UNDER EAVES ARE OPEN TO ATTIC. ACCESS FOR BIRDS AND ANIMALS

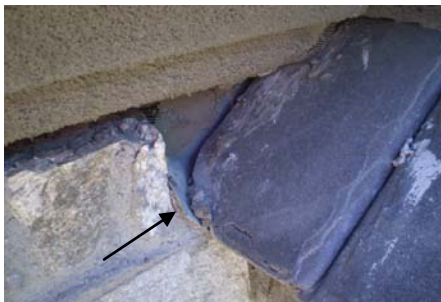
PHOTO #29 DIVERTER DOES NOT PROJECT BEYOND FACE OF STONE VENEER- WEST

4.48- **Diverters**- there are sheet metal diverters installed at wall to roof unions. These diverters are not projecting beyond the wall face. Water from the roof is draining over the stone veneer and stucco walls due to the improper diverter installations. Extend the diverters 1" beyond the face of the siding and stone veneers as needed.

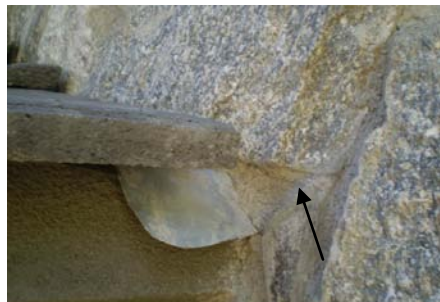
PHOTO #30 DIVERTER IS BURIED IN STONE AND MORTAR- WEST

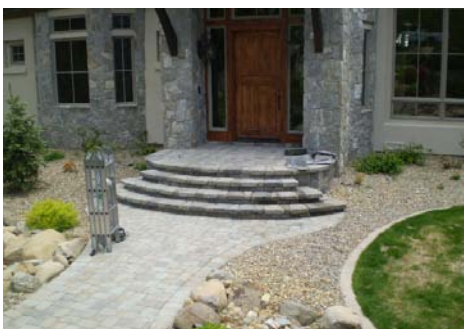
- 3.41- Hand Rails missing- there are several stairs at the exterior with 4 risers and no hand rails installed. West- UBC 1003.3.3.1
- 3.42- Hand rail location north east- the hand rail does not run along side the stairs treads. – UBC 1003.3.3.1

PHOTO #31 NO HAND RAILS AT ENTRY STAIRS

4.41- **Hand Rails missing**- There are several sets of stairs at the entry walk that do not have hand rails installed. Install proper hand rails at these stairs as required.

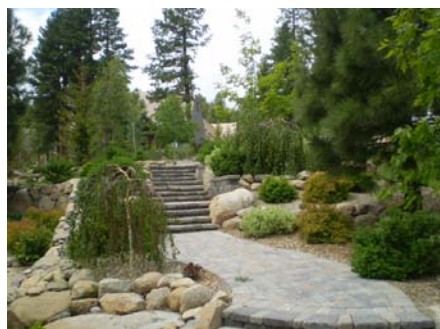
PHOTO #32 NO HAND RAILS AT ENTRY STAIRS, WEST

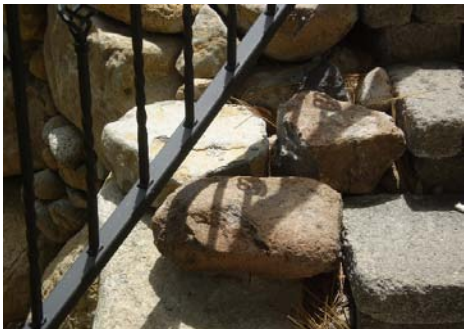
PHOTO #33 HAND RAIL IS NOT ADJACENT TO STAIRS AT NORTH EAST CORNER

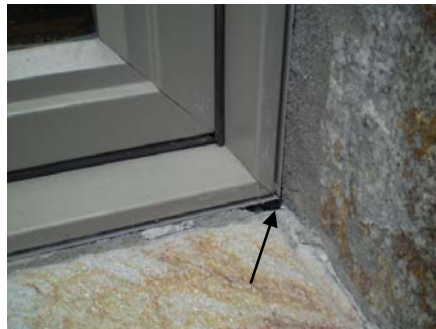
PHOTO#34 SEALANT NEEDED AT WINDOWS AND DOORS TO PREVENT WATER ENTRY

4.43- **Seal around doors/windows/penetrations**- There are cracks, gaps and separations at windows, doors, conduit penetrations, wire penetrations, etc. throughout the exterior of the home. Install proper sealant to prevent air or water intrusion.

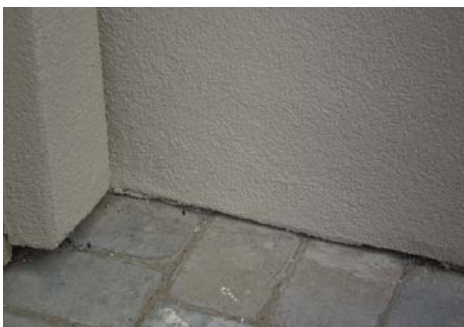
- 3.45- animal damage at eaves- several locations north, east and south
- 3.46- Weep screed clearance south- the required 2" clearance is not provided at base of wall UBC 2506.5

PHOTO #35 MISSING 2" CLEARANCE TO WEEP SCREED AT SOUTH

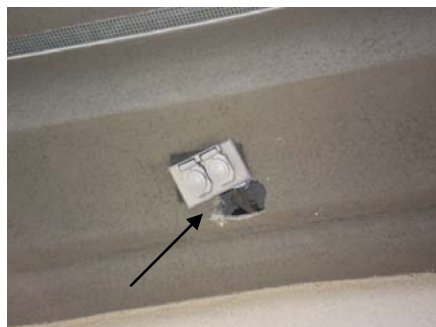
PHOTO #36 HOLES IN SOFFIT AT SEVERAL LOCATIONS

4.45- **animal damage at eaves**- birds have been damaging the soffit foam materials at the north, south and east sides. Repair the bird damage. Note: this damage appears to be caused by woodpeckers. These birds often will attempt to extract insects that the birds can hear. The neighbors units that has the same foam soffit details do not have bird damage that is evident. Moisture leaking into the soffit may be part of the cause for this bird activity. Consult specialist. Repair as needed

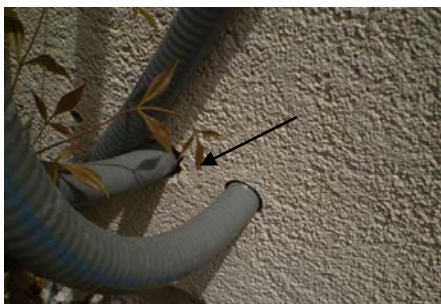
PHOTO #37 UNSEALED PENETRATIONS AT CONDUITS SOUTH

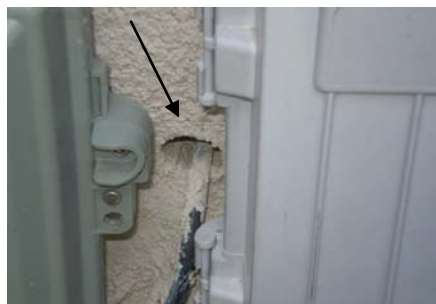
PHOTO #38 HOLES IN STUCCO AT CABLE/PHONE BOX NORTH

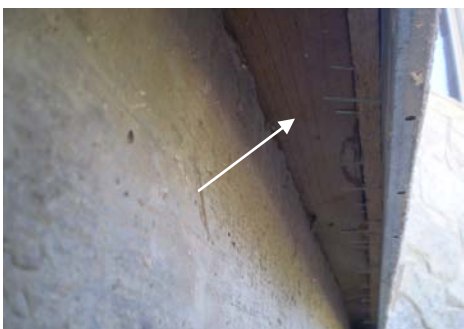
- 3.47- Over hang at mud sill- west- the wall framing is cantilevered over the stem wall. Suspect support, air infiltration probable- no sealant installed- Consult engineer, MEC 502.3

PHOTO #39 MUD SILL IS CANTILEVERED OVER STEM WALL AT WEST

4.47- **Over hang at mud sill**- west- The mud sill is visible at the west side of the home, behind the stucco weep screed. The mud sill is projected 2.5" over the foundation stem wall. Consult an engineer. Determine if there is a structural issue with the cantilevered exterior wall sill plate. Repair as needed. At a minimum, there is considerable air infiltration that will occur at this location. Proper repairs should be made to caulk, seal, and insulate the exposed wood wall base.

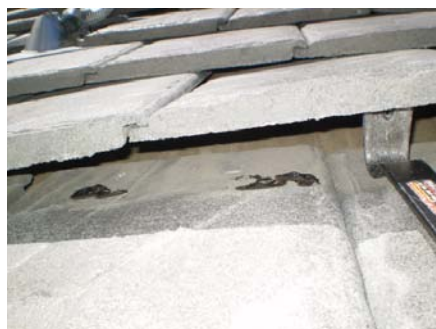
PHOTO #40 RANDOM FIELD TILE HAS NO NAILS INSTALLED. ADHESIVE ONLY

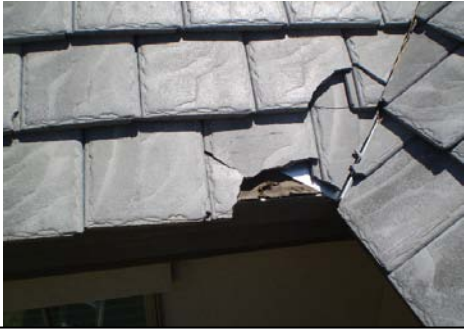
PHOTO #41 FELT DOES NOT PROJECT OVER ROOF EDGE. BROKEN TILE

4.56- **1" felt projection at eave**- there is felt paper installed under the tile. The felt does not project 1" beyond the face of the soffit/fascia. This is allowing water to be directed back into the soffit. As noted above, an investigation is warranted to determine the extent of water damage behind the soffit, including possible environmental issues. The felt paper should be properly extended beyond the face of the soffit/fascia as required.

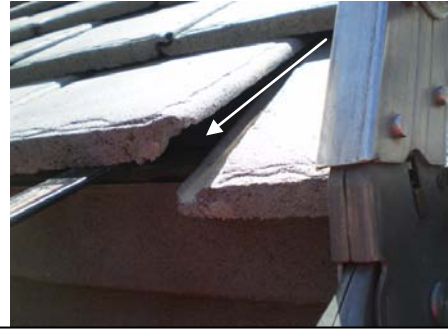
PHOTO#42 RANDOM CHECK OF EDGE TILE. MISSING WIND CLIPS

4.53- **Wind clips**- a random check revealed some edge tiles are missing the required wind clips.

Install wind clips where missing

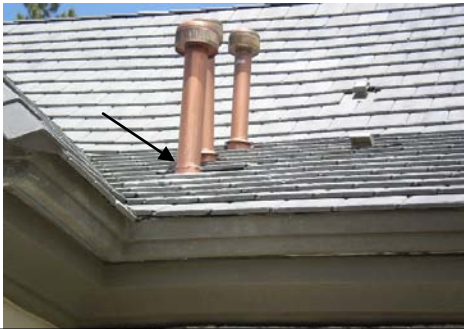
PHOTO #43 MISSING STORM COLLAR, LIFTED TILES, SOUTH

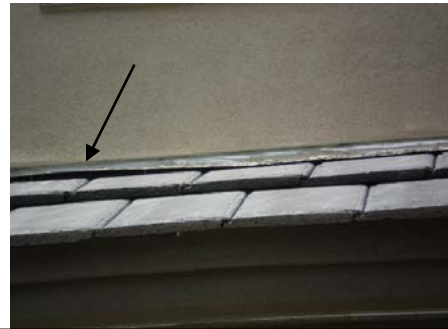
PHOTO #44 LIFTED WALL TO ROOF FLASHING

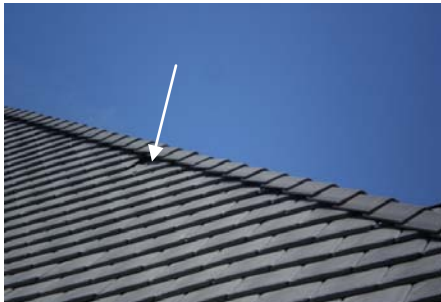
PHOTO #45 MISSING TILE

4.51- **Damaged tile**- repair and replace all damaged field tile, rake tile, valley tile, etc.

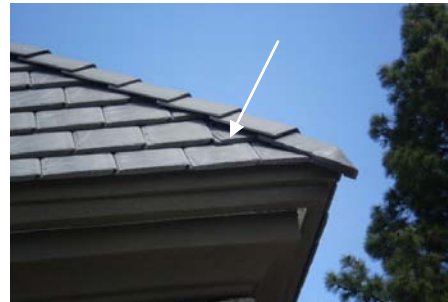
PHOTO #46 SHIFTED TILE. LOOSE TILE

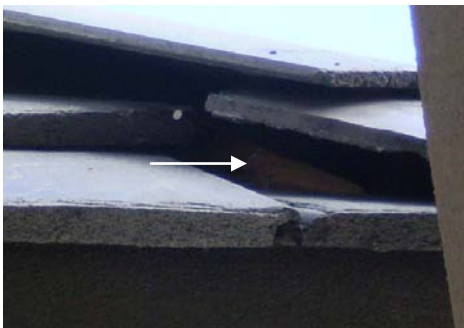
PHOTO #47 VISIBLE NAILERS. IMPROPER WEATHER BLOCKING. THIS PHOTO IS EAST

4.510- **Visible nailers** – the bare wood of the nailers are visible throughout the hip ridges. Make repairs as needed to prevent water access to the bare exposed wood.

4.511- **Improper weather blocking**- the weather blocking under the hip and ridge tiles is inadequate. It is not installed in a manor that will direct water over the surface of the tiles. Repair all the weather blocking as needed to reduce the amount of water that can access under the tiles.

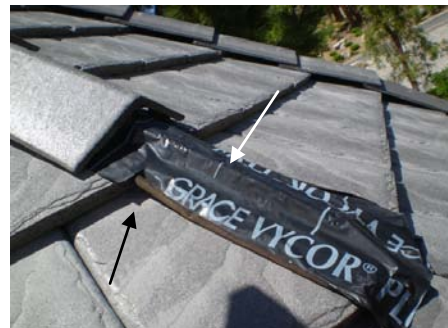
PHOTO #48 MISSING NAILER AT HIP. GAPS AT WEATHER BLOCKING WHERE WATER ENTERS

4.59- **Missing nailers**- there are areas where the nailers were not completely installed. There is missing backing for the hip tiles. Install nailers where missing.

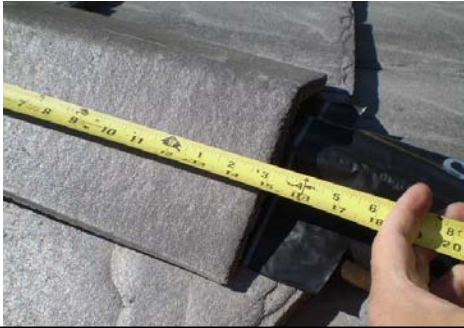
PHOTO #49 15" EXPOSURE ON SOME TILES

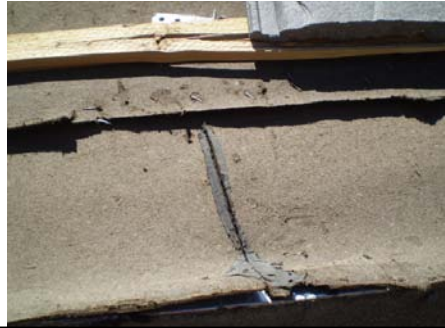
- 3.57- Damage to felt- missing tiles from snow damage revealed damaged felt repaired with mastic only. Inadequate repair.
- 3.58- Improper installation of ice dam protection- ice shield does not project over fascia/soffit. Water enters eave

PHOTO#50 ORIGINAL DAMAGE TO FELT WAS PATCHED INCORRECTLY.

4.57- **Damage to felt**- some tiles were missing from snow damage. (and the fact that several had no nails or adhesive installed) There is some damaged felt paper at the eave. The paper was cut or torn during construction. A small amount of roof mastic was applied on the torn paper areas. This is not an adequate repair. Water has accessed through the torn paper as the mastic was not a proper repair. Repair the damaged felt under the tiles as needed. This will require an invasive examination.

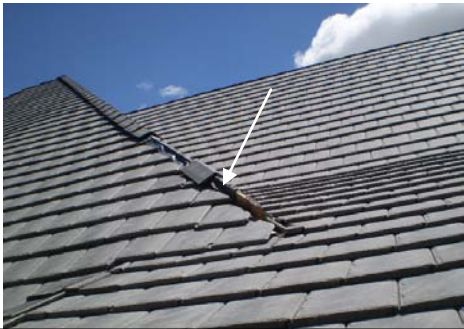
PHOTO #51 MISSING, DAMAGED TILE. INCORRECT WEATHER BLOCKING

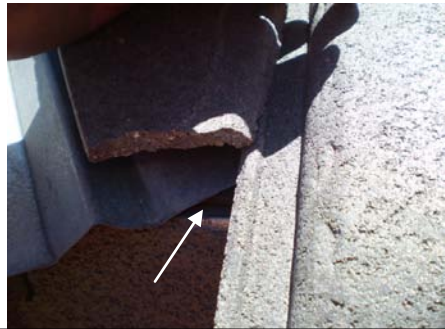
PHOTO #52 VALLEY DOES NOT PROJECT 1" BEYOND ROOF EDGE. BROKEN TILE

4.55- **1" valley flashing projection**- some of the valley sheet metal flashing does not project 1" beyond the face of the soffit/fascia. Water has been running back into the soffit areas. Investigations are warranted throughout the perimeter of the building as environment conditions may exist as well as water damage. Extend the flashing to the required 1" over hang.

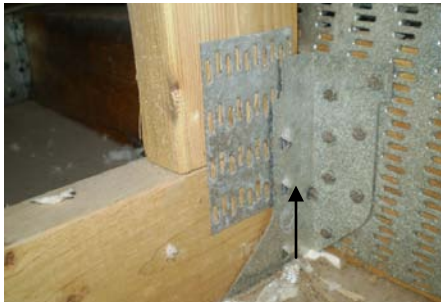
PHOTO #53 HARDWARE NOT NAILED AT MANY LOCATIONS IN ATTIC

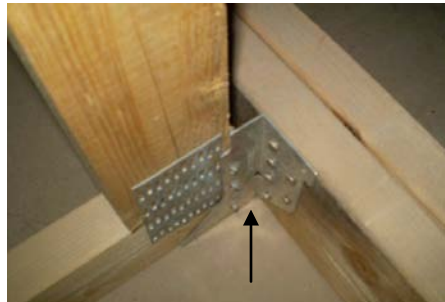
PHOTO #54 TRUSSES ARE NOT FLUSH WITH DRAG TRUSS. UNABLE TO NAIL AT BRACKET

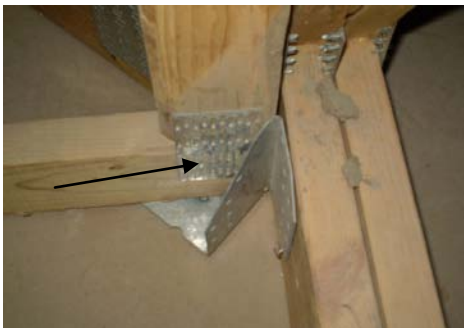
PHOTO #55 IMPROPER HARDWARE AT SOUTH ABOVE GARAGE. NO NAILS OR FASTENERS

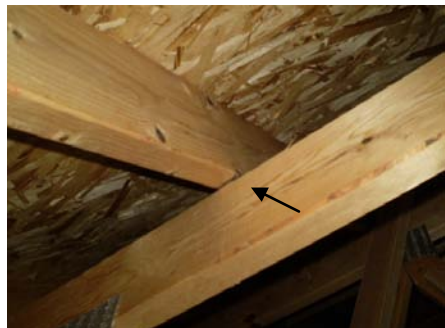
- 3.515- Truss hangers- missing nailing at many hangers. Gaps are present in framing preventing installation of fasteners
- 3.516- Truss to rafter connections- no nails or fasteners installed at hip trusses and rafter unions

PHOTO #56 NO HARDWARE, NAILS OR CONNECTORS AT HIP TRUSS TO RAFTER ABOVE

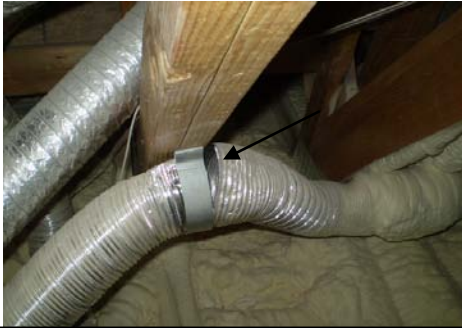
PHOTO #57 DAMAGED EXHAUST DUCT SOUTH

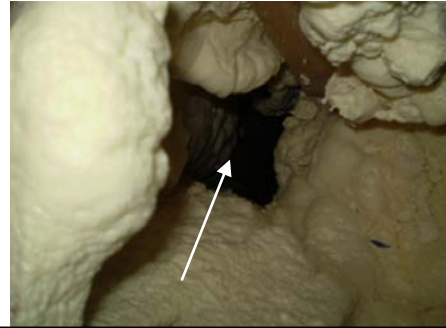
- 3.519- Fire draft stop - missing draft stop, open chase by dining room – UBC 708.3.1.3
- 3.520- Nailers for rake tile- missing support under rake edge tiles. Nails are installed in stucco only.

PHOTO#58 OPEN CHASE, NO FIRE DRAFT STOP. NEAR DINING ROOM/ENTRY

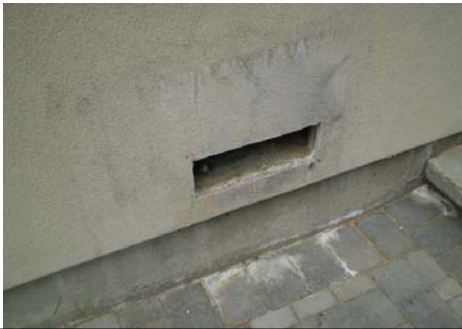
- 3.61- Missing screens at foundation vents – 2 vents are removed at east- UBC 2306.7
- 3.62- Obstructed foundation vents – floor joists block vents at west- UBC 2306.7, Title 100

PHOTO #59 FOUNDATION VENTS ARE MISSING AT 2 LOCATIONS EAST

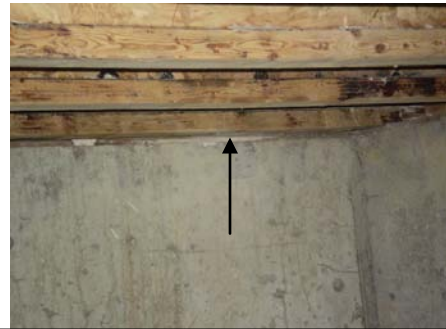
PHOTO #60 SOME FOUNDATION VENTS ARE BLOCKED BY JOISTS AT INTERIOR- NO INSULATION

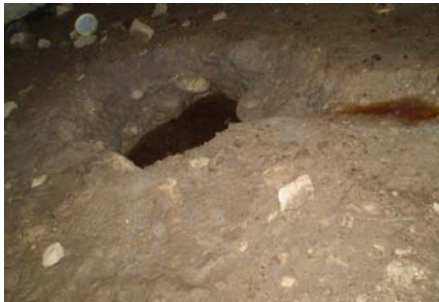
- 3.65- Conditioned air ducting- ducting removed- UBC 310.11
- 3.66- Insulation- insulation removed – MEC 502.2.3
- 3.67- Water intrusion- water accumulates in crawl area- UBC 1804.7

PHOTO #61 STANDING WATER, MUDDY SOILS.

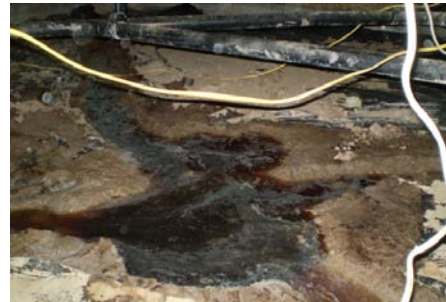
PHOTO #62 STANDING WATER, UNSUPPORTED WIRES.

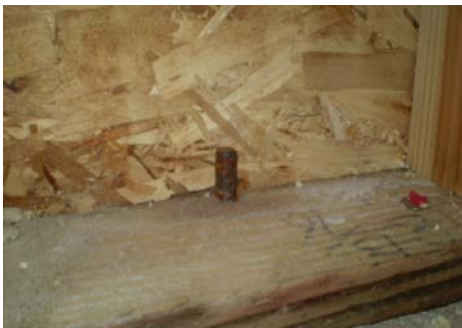
- 3.610- notched joist west bath- joist is notched at west bath shower – UBC 2320.8 + I Joist manufacture
- 3.611- nut/washer- nut and washer are missing on anchor bolt by center 6X10 post- non compliance with design drawings/blue prints

PHOTO #63 MISSING NUT/WASHER AT ANCHOR BOLT BY POST SHOWN IN PHOTO #64

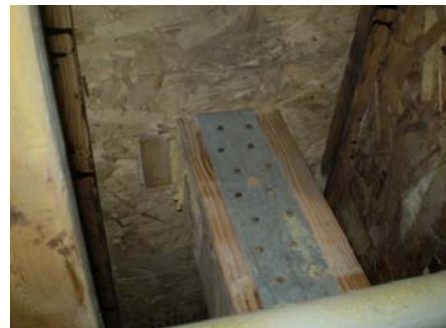
PHOTO #64 6x6 POST IS STRAPPED AT SPLICE. PLANS SHOW 6x10 POST AT THIS LOCATION. NO PB

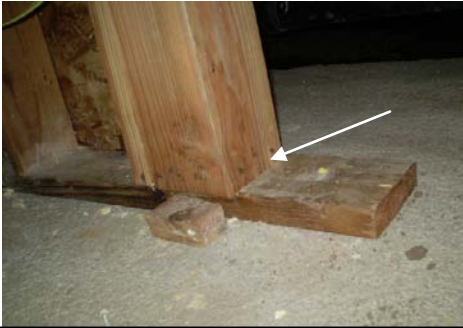
3.616- Post base investigation- posts are sitting on 2x6 mud sill. Some compression is observed from post above. No post base bracket is installed-

PHOTO #65 PLANS SHOW 6x10 POST,
POST IS 6x6- NO POST BASE
BRACKET. COMPRESSION AT SILL

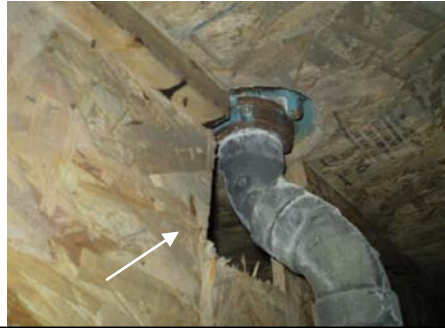
PHOTO#66 CUT FLOOR JOIST
UNDER WEST BATH SHOWER

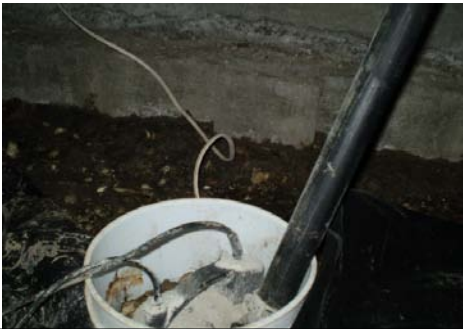
PHOTO #67 INCOMPLETE
INSTALLATION OF SUMPS. NO BACK
FLOW DEVICE IN WASTE LINE

4.213- **Sump installation + no back flow device-** water has been accumulating under the home on a regular basis. Even now after, water is accumulating at pockets. An investigation as to the source of the water should be made. Repairs should be made, after the water source is identified, to prevent water accumulations under the home. It is recommended that repairs occur at the exterior of the home, prior to water accessing the crawl area. However, if the method of extracting water under the home is to be completed by sump pumps, proper installations of the components should be installed. Including, but not limited to: installing sumps, installing proper channels to direct water to the pumps, installation of drain rock, installation of ground fault protected receptacles, proper draining of the water to an approved location. (it is not recommended that the water be drained into the sewer waste line) if the water is drained into the sewer waste line, proper back flow devices are needed to prevent sewage back ups into the crawl area. Consult a specialist. Repair as needed.
