**JAV
ESTIMATING
SERVICES, INC**

HOME INSPECTION REPORT

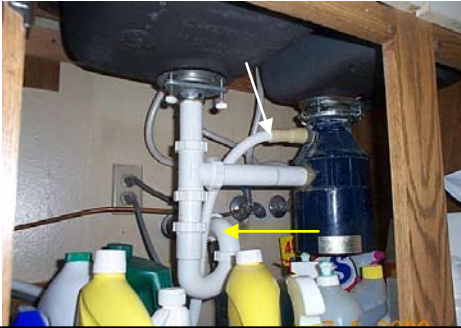
PHOTO #1 LEAK AT TRAP ARM UNDER KITCHEN SINK, NO LOOP OR AIR GAP IN DISHWASHER DRAIN

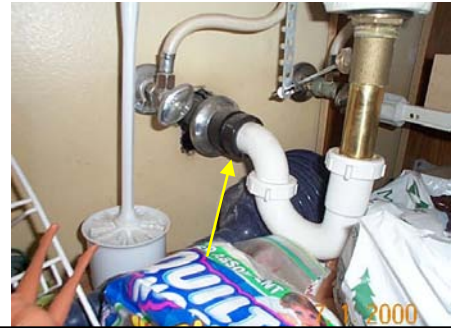
PHOTO#2 LEAK AT TRAP ARM UNDER BATH SINK UP STAIRS

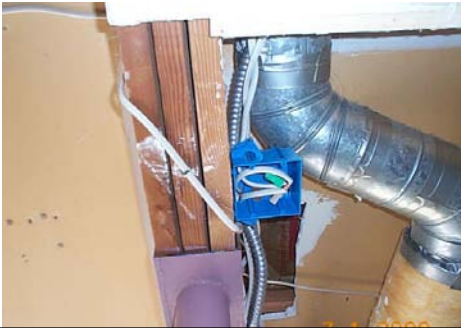
PHOTO #3 HOLE IN SHEETROCK AT GARAGE CEILING/FIRE WALL. MISSING COVER AT JUNCTION BOX

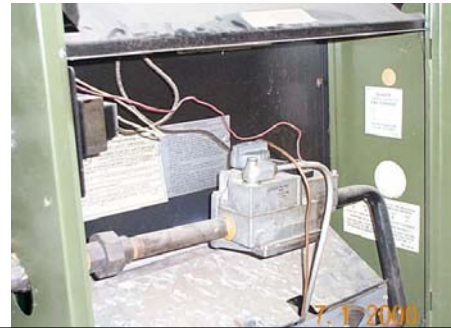
PHOTO #4 HEATER AT GARAGE

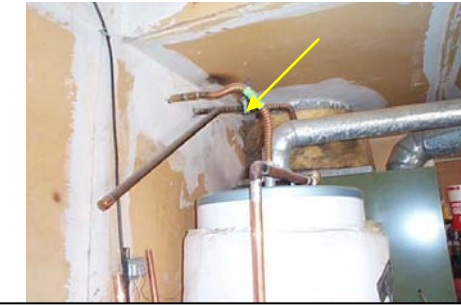
PHOTO #5 LEAK AT WATER HEATER COLD WATER SHUT OFF VALVE

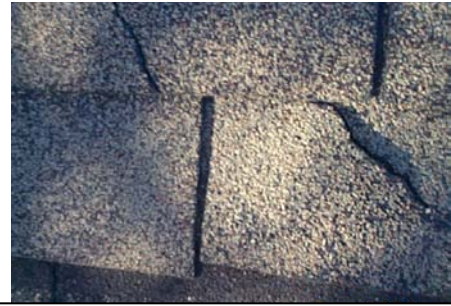
PHOTO #6 CRACKS, BRITTLE SHINGLES AT TOP LAYER AT SOME AREAS

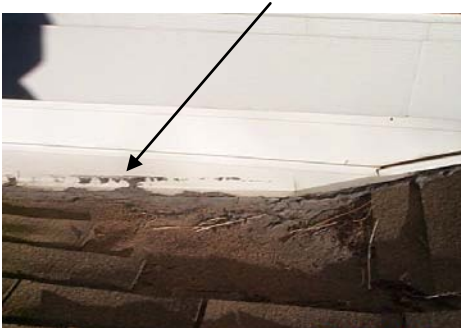
PHOTO #7 MAINTAIN SEALANT AT WALL TO ROOF UNION ABOVE KITCHEN

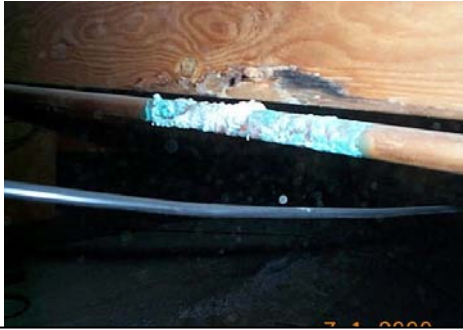
PHOTO #9 LEAK AT SUPPLY LINE UNDER KITCHEN AT CRAWL AREA- NAIL PENETRATED PIPE

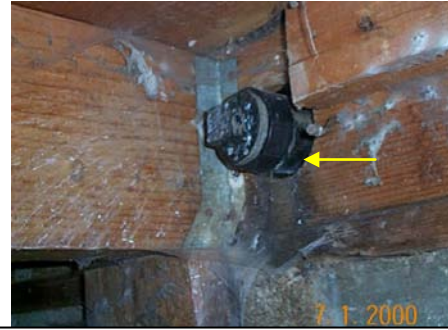
PHOTO#10 LEAK AT CLEAN OUT AREA UNDER KITCHEN SINK AT CRAWL AREA

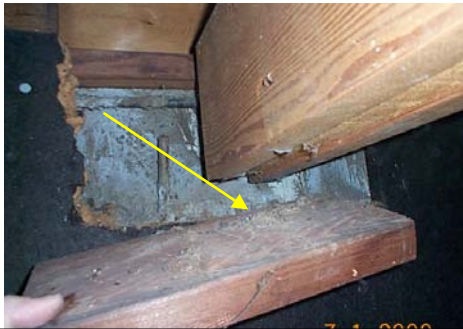
PHOTO #11 GIRDER IS NOT BEARING ON FOOTING AT SOUTH NEAR LIVING ROOM FIRE PLACE.
